***FINAL REPORT  
OF THE PROJECT***

**MORPHOLOGICAL STUDY OF KRISHNA AND TUNGABHADRA  
BASINS USING REMOTE SENSING TECHNIQUE**

**Central Water Commission  
Ministry of Water Resources  
Government of India**

**ENVIRONMENTAL AND WATER RESOURCES ENGINEERING DIVISION  
DEPARTMENT OF CIVIL ENGINEERING  
INDIAN INSTITUTE OF TECHNOLOGY, MADRAS  
CHENNAI - 600 036**

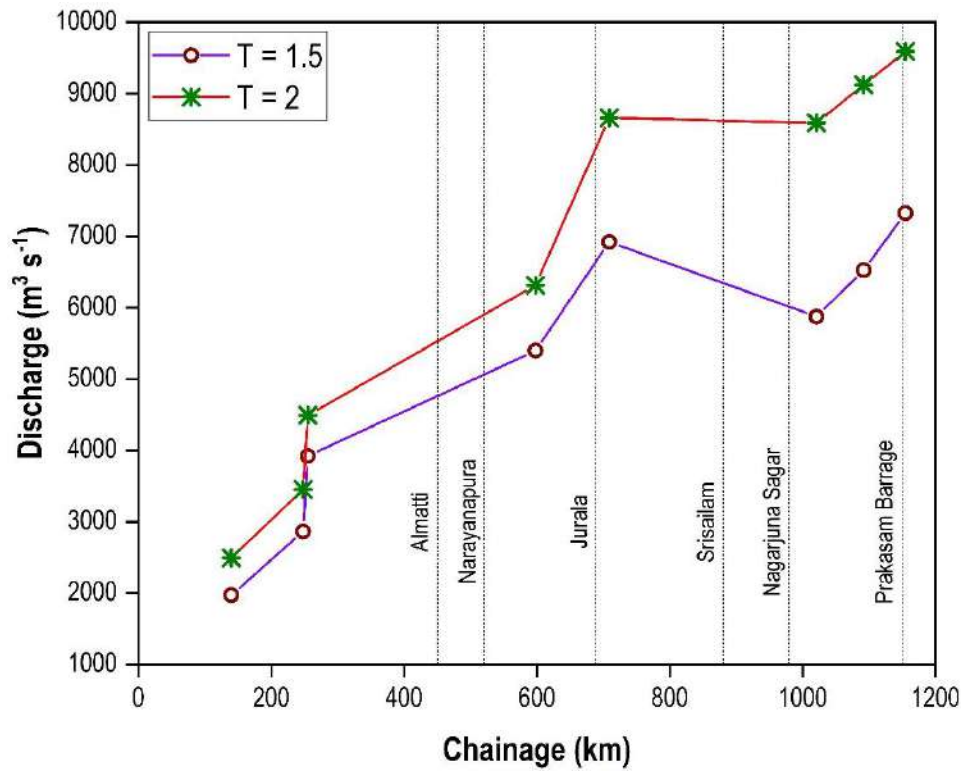
Fig. 14: Spatial variation of the discharges of 1.5 year and 2 year return periods, Krishna River

The longitudinal variability of the discharges of 1.5 year and 2 year return periods are shown in Figs. 14 and 15. It is noted that the discharge values increase drastically towards downstream, especially in the upstream section draining to the Jurala Dam, perhaps due to the contribution of flows from the major tributaries (other than Bhima River) of the Upper Krishna Basin. However, the variability in the discharges is substantially less in the downstream sections, where the major dams, such as Srisailem and Nagarjuna Sagar are located. Further, the gradual increase (although minor) downstream of the Nagarjuna Sagar dam could be the result of the flows contributed by the tributaries, viz., Musi, Paleru, Munneru, and Wyra Rivers. However, in Tungabhadra River, the downstream variability is remarkably lesser, compared to the Krishna River. Moreover, a rise in the discharge is observed only in the downstream of the Tungabhadra Dam.

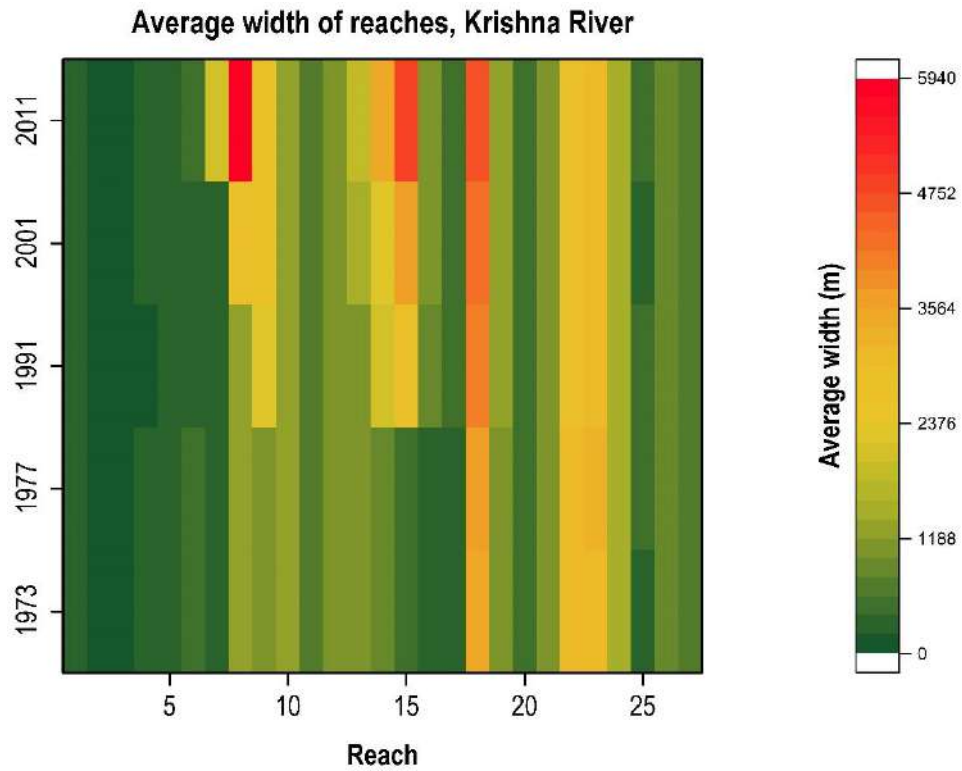
**Fig. 21:** Spatio-temporal variation of mean width of river reaches (KR\_01 to KR\_27) of Krishna River during 1973 and 2011. Red color indicates an increase in width due to reservoir impoundment.

In general, the mean width of the reaches of both Krishna and Tungabhadra rivers increases towards downstream as a result of the increasing discharges. However, a few exceptions are observed in both rivers. The changes in the order of magnitude prominently reflect inundation of river valleys due to the construction of dams. For example, the sudden increase in the mean width of KR\_08 (1266 m), KR\_09 (1129 m) and KR\_10 (1368 m) compared to their upstream and downstream reaches such as KR\_07 (374 m) and KR\_11 (707 m), respectively (Table 28) is due to the submergence of land area due to Almatti and Narayanpura dams and reservoirs (Fig. 8). Such an increase is also evident in KR\_17 and KR\_18 (Nagarjuna Sagar reservoir) as well as TR\_05 and TR\_06 (Tungabhadra reservoir). On the other hand, a drastic reduction of mean width is also occurred in KR\_16 and KR\_17, compared to upstream reaches, which is due to the incised nature of the river valley between Kurnool and Nagarjuna Sagar dam (Fig. 23). In such segments, the channel changes in the horizontal dimension are restricted due to the confined valley nature and bedrock channel walls.

The variation of the width of most of the study reaches of both Krishna and Tungabhadra rivers across the years (i.e., 1973-2011) shows hardly any significant differences, except in a few reaches (e.g., KR\_07 to KR\_09, KR\_13 to KR\_18, TR\_05 and TR\_11; Tables 28 and 29). This variability is also correlated with the areal extent of reservoir impoundment in the upstream of the aforementioned dams. For example, Almatti dam was completed in 2000, and Srisaillam in 1984 (Appendix I), and the same is reflected in KR\_07 and KR\_08 and KR\_14 and KR\_15.

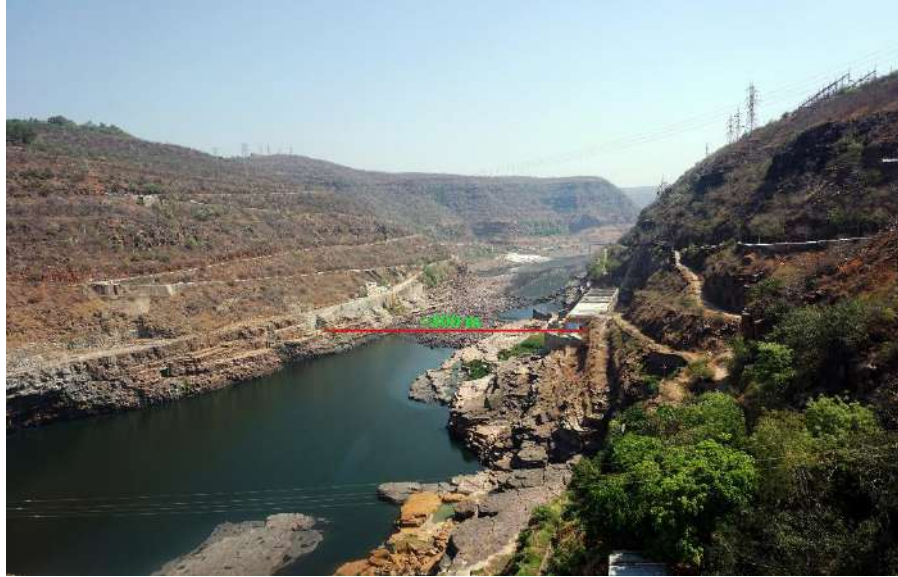
**Fig. 23:** Downstream view of the incised river reach (KR\_17) from Srisaillam dam. The river segment (seen in the background) is incised into bedrock with an elevation drop of roughly 250 m

Even though KR\_15 is also located in the upstream of the Srisaillam dam, the variability in width across the years is not reflected, which is due to the incised nature of the river valley. In addition, the centerline of the river reaches in Krishna as well as Tungabhadra rivers also show insignificant shifts, except in the reaches that are influenced by reservoirs. Such geomorphic expressions are usually interpreted as a sign of channel stability.

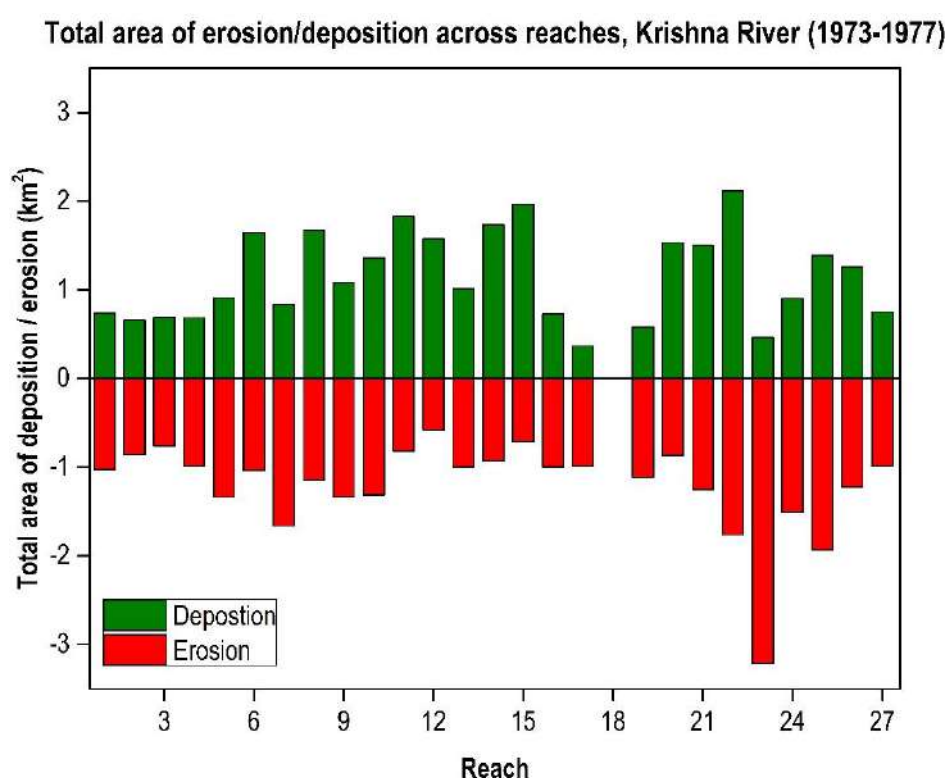
**Fig. 61:** Variation of erosion and deposition across the reaches of Krishna River during 1973-1977

In order to understand the behavior of the study reaches of Krishna and Tungabhadra rivers, total erosion and deposition along both the banks are compared (Figs. 61 to 70). The bank erosion/deposition pattern of the reaches of Krishna River (Figs. 61 to 65) indicates that the downstream reaches exhibit a higher rate of erosion as well as deposition across the time periods. One of the reaches is KR\_22, where high erosion and deposition are evident during most of the assessment periods. This is mainly because of the contrasting nature of the river banks, i.e., either of the banks is vulnerable to erosion, whereas the other promotes deposition. The net erosion (i.e., erosion - deposition) of the reaches during the study period indicates that KR\_24 experiences high erosion compared to deposition during all the assessment periods, where KR\_26 and KR\_27 have high net erosion during most of the assessment periods. In addition, reaches, such as KR\_01, KR\_04, KR\_05, KR\_13, KR\_14, and KR\_17 also exhibit relatively high erosion compared to deposition along the banks.

The high rate of bank erosion and deposition in the downstream reaches of Krishna River may be correlated with the braided nature of the study reaches, as the deflection of the channel flows around the developed sand bars could be a primary cause of bank erosion and associated channel widening. In the Brahmaputra River, Akthar et al. (2011) observed that bank erosion along the braided reaches was induced by the flow concentrations due to the temporal evolution of multiple channels. Thorne et al. (1993) also identified bank migration processes, which are driven by bar development and migration in braided reaches operating at smaller spatial (3-6 km) and over shorter temporal scales (2-5 years). However, Ta et al. (2013) reported that the braided channel in the sand banked reach of upstream of the Yellow River was characterized by an increasing trend in both channel deposition and lateral channel erosion in response to decreased flows. It is further explained that erosion from toes of the channel bank causes bank failure, delivering excess volumes of sediment into the central portion of the channel, and thereby developing a bank-to-channel sediment transfer. This could have been a potential mechanism for the relatively higher rates of bank erosion as well as deposition along the braided reaches of the Krishna River.

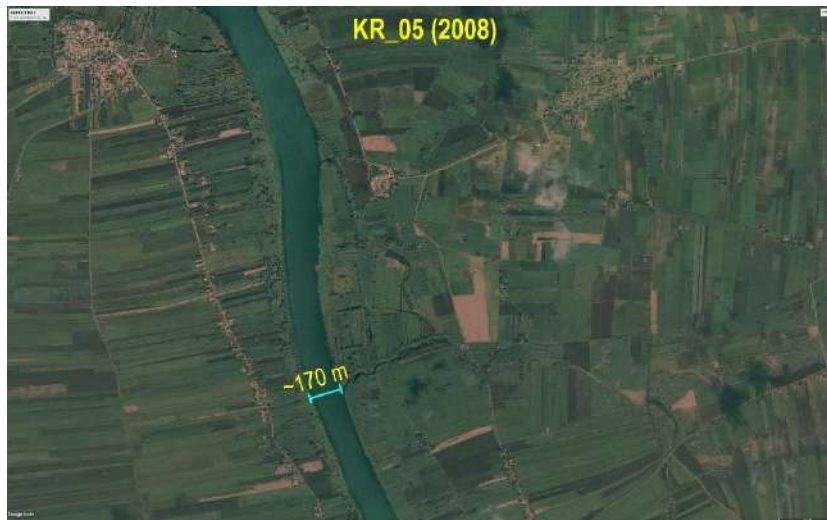
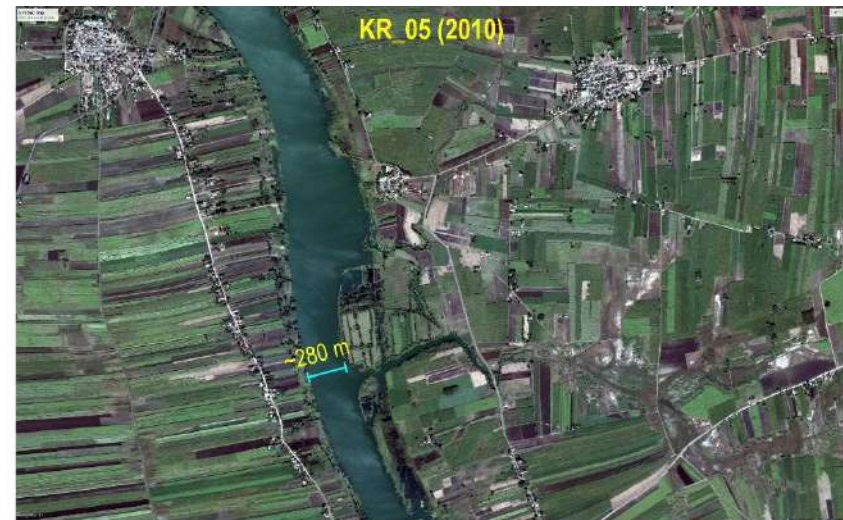
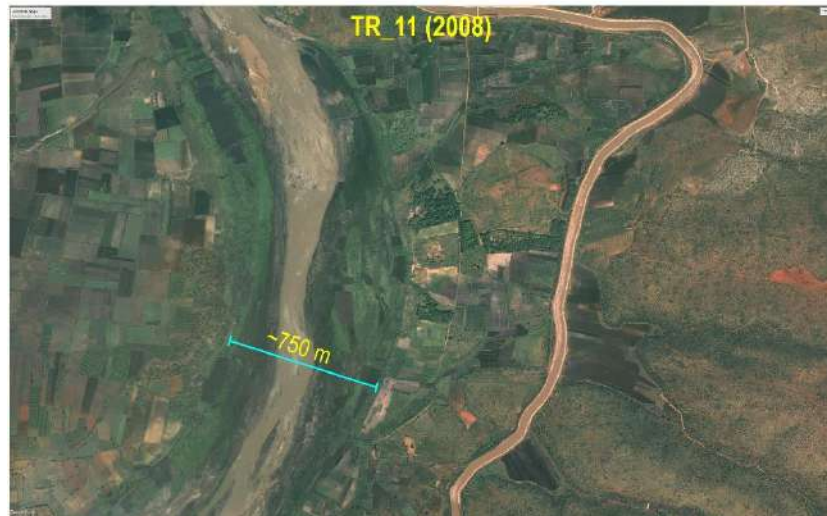
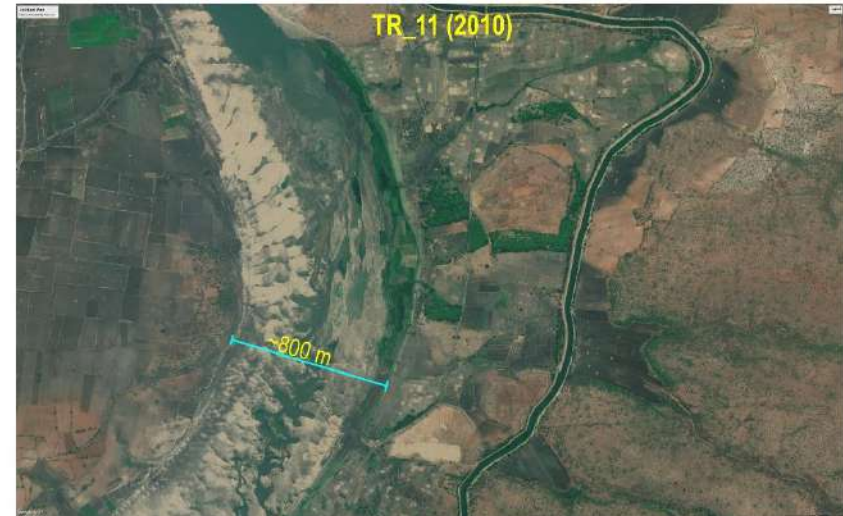
**Fig. 78:** Comparison of the channel bank lines: Pre- and post- 2009 flood scenarios (Source: Google Earth)

The changes in channel geometry due to the flood event occurred in 2009 are evident in the reaches, both in Krishna and Tungabhadra rivers. In addition to the extensive bank erosion and channel widening, redistribution and deposition of coarse sediments within the channel as well as along the banks are observed (Fig. 78). The changes in channel morphology have also been verified during the field visit in the downstream of Tungabhadra (TR\_11) as well as downstream of Srisailem and Nagarjuna Sagar dams (KR\_17 and KR\_19). In KR\_17, despite its incised nature and rocky exposure on the channel walls, the reach has been subjected to severe changes in the channel morphological perspective.

The removal of the unconsolidated materials deposited along the banks of KR\_17 and redistribution and deposition further downstream is observed in the downstream of Srisailem dam. Similar erosion patches have been developed along the downstream of Nagarjuna Sagar dam. The coarser bed material (of boulder size) deposited in the tailwater section of the dam has been transported to further downstream during the 2009 flood (pers. comm.). In addition, large scour was also formed on the rocky channel wall of left bank immediate downstream of the Srisailem dam (Fig. 79), whereas the severe bank erosion occurred downstream of the Nagarjuna Sagar dam during the flood event (Fig. 80). However, the effect of the 2009 flood is not evident along the entire reaches as the downstream portion of KR\_17 is inundated (Appendix XIV) due to the reservoir impoundment of the Nagarjuna Sagar dam.

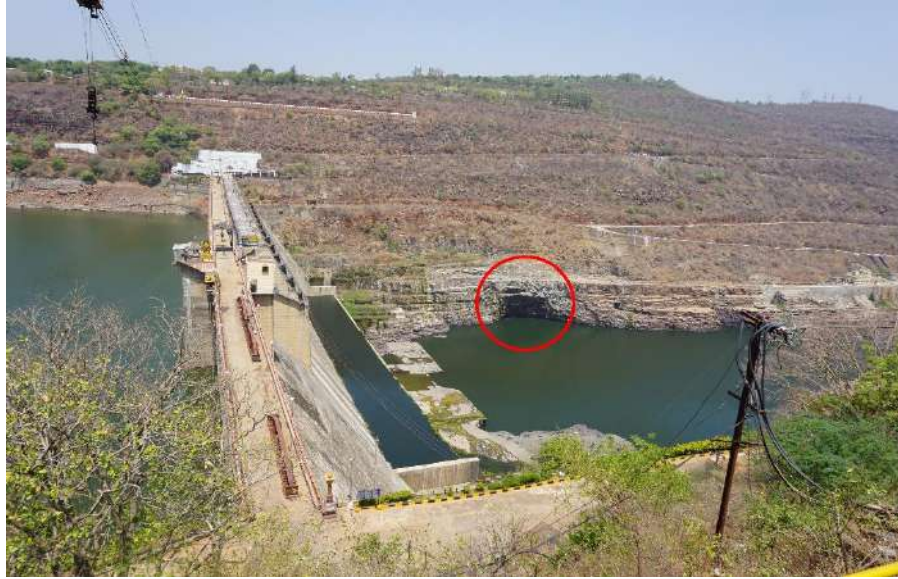
**Fig. 79:** Scouring occurred on the left bank channel wall in KR\_17 during the 2009 flood; view towards NNE

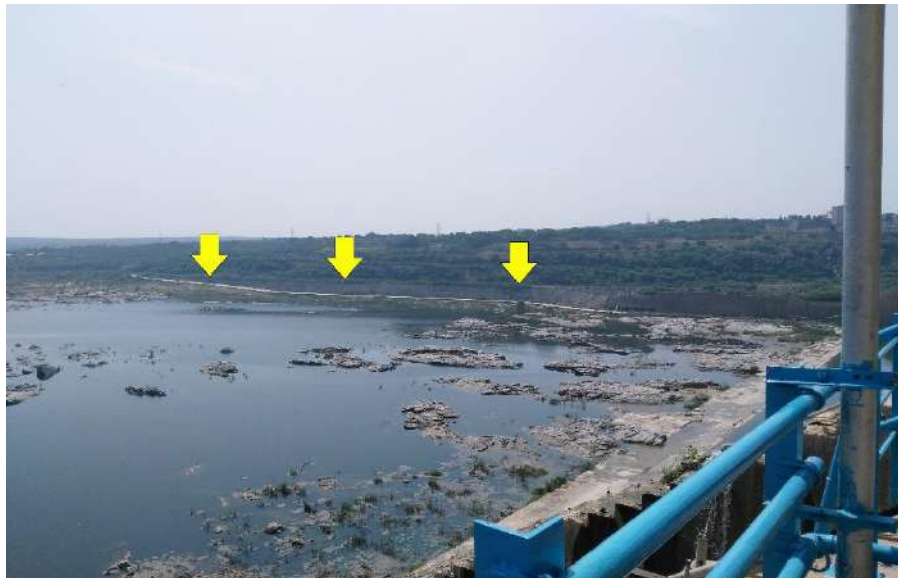
**Fig. 80:** Bank protection measures along the right bank of KR\_19 implemented after the 2009 flood; downstream view from Nagarjuna Sagar Dam

The main difference in the reaches between downstream of Srisailem and Nagarjuna Sagar dams (KR\_17 vs. KR\_19, KR\_20, and KR\_21) is the valley topography, where the former is developed in an incised valley, while the latter is formed in a more or less unconfined valley setup. Hence, the effects of the 2009 flood were more severe (both in terms of bank erosion) in the downstream reaches of Nagarjuna Sagar dam. The mean width of erosion also attests the same (Table 35), i.e., the mean width of erosion of KR\_17 during 2001-2011 is 8.9 m and 6.4 m for left and right banks, respectively. However, the mean width of erosion along the left bank of KR\_19, KR\_20 and KR\_21 is 11.6, 17.2, and 27.0, respectively, and that in right bank is between 22.0 m and 25.0 m. The flood severity was significantly high in the eastern coastal plains as well as in the

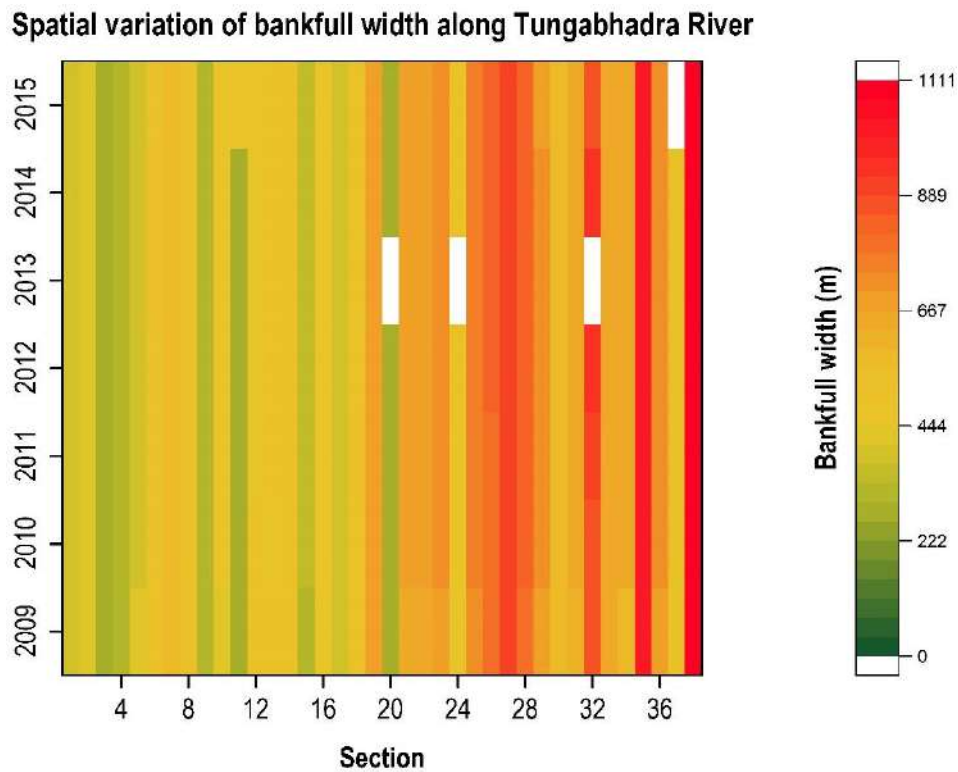
**Fig. 86:** Temporal variation of bankfull width across the measured cross-sections along Tungabhadra River. White patches denote data gaps.

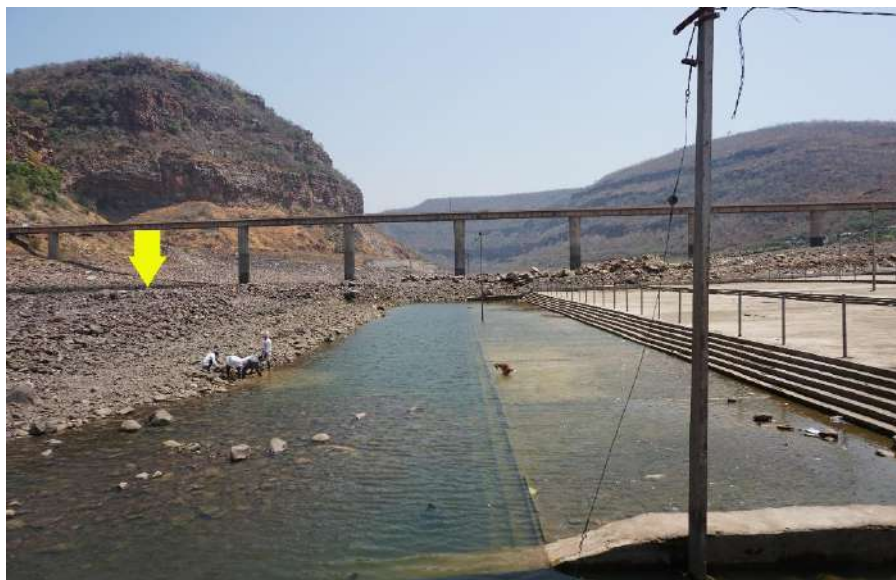
**Fig. 94:** Aggradation of channel bed in KR\_17 (downstream of Srisailem dam) after 2009 flood

However, several depositional patches have also been identified in the downstream reaches of the above-mentioned reaches even after the downstream of the hydraulic structures. For example, patches of sediment deposition (and aggradation of bed) were observed in the downstream channel segment of Srisailem dam (KR\_17), which is contrary to the previous studies, which all observed degradation of the bed. It is also interesting to note that the sediment size ranges from very fine sand to boulder (Fig. 94). There are two reasons for the development of the depositional patch downstream of the Srisailem dam. The first one is the flood happened during 2009, which has overtopped the dam and displaced the sediments accumulated in the tailwater plunge pool to further downstream (pers. comm). In addition, there are significant contributions from one of the downstream tributary, joining the mainstream. A huge amount of sediments were deposited on the tributary channel (mainly during the construction of the powerhouse), which also moved downstream

during exceptionally high flows. Development of depositional patches downstream of dams was also supported by the observations of Philips et al. (2005). In the study, Philips et al. (2005) reported that channel scour and erosion is prominent for about 60 km downstream, but beyond 60 km downstream, the river is characterized by extensive sediment storage and reduced conveyance capacity.

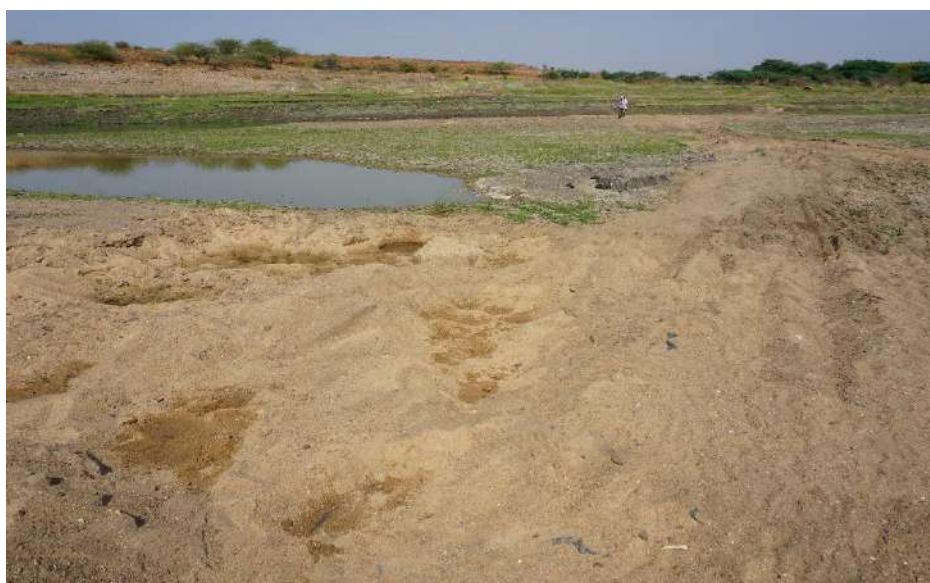
**Fig. 95:** Extraction of sand from the channel bed in TR\_11, Tungabhadra River

Unscientific extraction of sand and gravel from the banks and channel is a major problem in several reaches of Krishna and Tungabhadra rivers (Fig. 95). In fact, the mining of the channel bed and in-channel bars results in channel instability through the direct disruption of pre-existing channel geometry or through the effects of the incision and related undercutting of banks (Collins and Dunne, 1989). Further, the discontinuity in the sediment supply-transport balance tends to migrate upstream as the river bed is eroded to make up for the supply deficiency (Knighton, 1984). The in-channel mining is sometimes promoted in alluvial rivers to increase channel flood capacity and prevent flooding (Rinaldi et al. 2005; Russell et al. 2016). However, the changes induced by gravel mining have direct and serious effects on human stakes, such as depletion of groundwater.

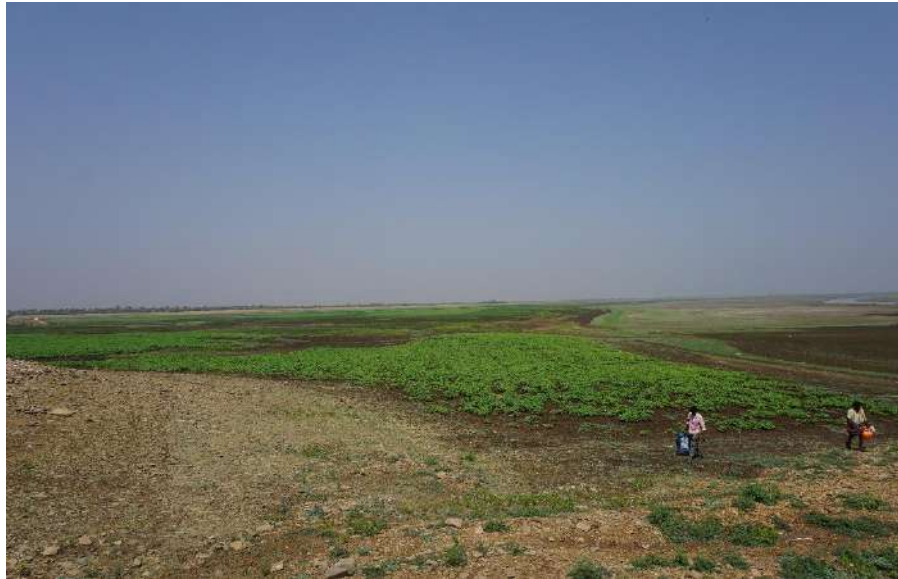
**Fig. 96:** Farming on the channel bed and floodplain in KR\_14, Krishna River

Riverbed vegetable farming is a pro-poor program intended to contribute on the livelihoods of people. Farming of the river bed and adjacent areas is observed in a few reaches of the Krishna and Tungabhadra rivers. In KR\_14, such large scale farming practices are observed (Fig. 96). The reach is characterized by seasonal flooding due to the inundated backwater of the Srisailem dam. After the river water recedes, short duration cover crops are planted into the fertile alluvium deposited along the banks, and the crops are harvested before the next inundation episode. However, disturbing the deposited sediments by plowing and other activities increase the sediment load into the channel.

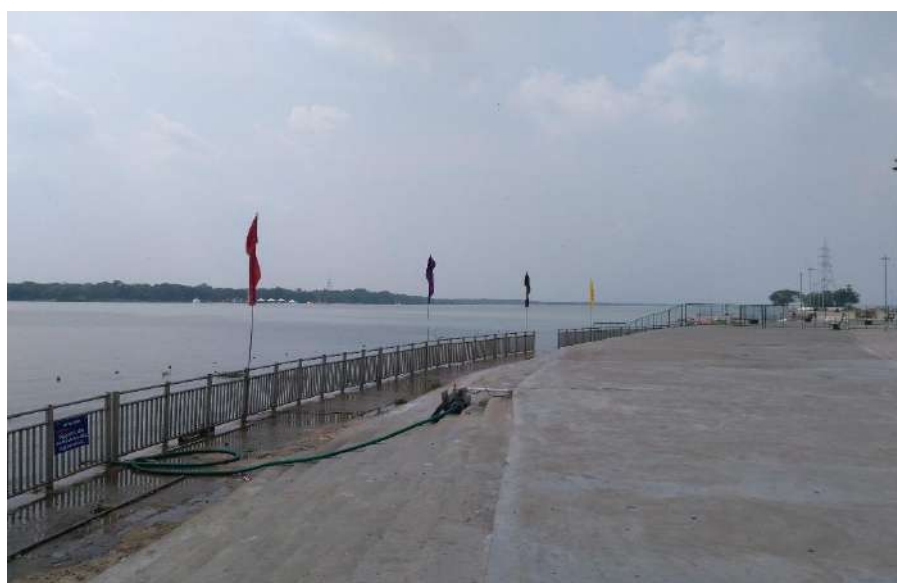
**Fig. 98:** Berms constructed on the right bank of KR\_22, upstream of Prakasam barrage

The inundated areas due to reservoir impoundment, while on lean period, are utilized for agricultural purposes, and a wide variety of short term crops are being cultivated in those areas. Since the inundated areas are characterized by the presence of a thick column of fertile alluvium, most of the areas are being under cultivation. In addition, the survey also witnessed the effects on the channel as well as on the banks during the 2009 flood, especially in TR\_11, KR\_14, KR\_17, KR\_22, and KR\_23. Even though the imprints of the flood event is preserved along the channel bed of these reaches, its effects on the banks are not evident in all the reaches due to the bank restoration as well as flood protection measures such as berms, cantilever retaining walls etc. (Figs. 98 and 99). Relicts of sand mining activities are visible in the channel bed as well as on the banks of KR\_22, where the mining pits go deep to roughly 2.5 - 3.0 m below the sediment deposition patches (Fig. 100). The total depth of sand column in the river channel reaches up to 30 m, especially in the reaches downstream of Prakasam barrage and deltaic regions, and has drawn attention for mechanical sand mining. Further, dumping of municipal wastes in the river bed (and burning) is also observed in the reaches, which are close to the urban centers (KR\_22 and KR\_23).

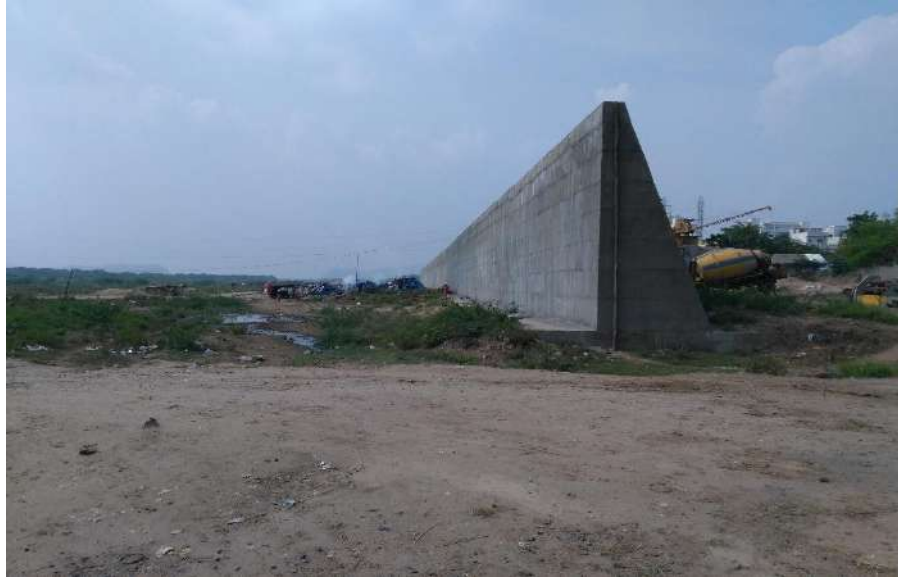
**Fig. 99:** Cantilever retaining walls constructed on the right bank downstream of Prakasam barrage;  
upstream view

In the context of the issues associated with river morphology, implementation of river training works as well as flood protection measures (Figs. 98 and 99), which are mostly structural measures, have already been initiated. However, implementation of the training works based on the prioritization of the river reaches will be beneficial for managing the morphological issues in a sustainable way. The proposed protection measures in the critical reaches of Krishna and Tungabhadra rivers are shown in Figs. 101 to 118.

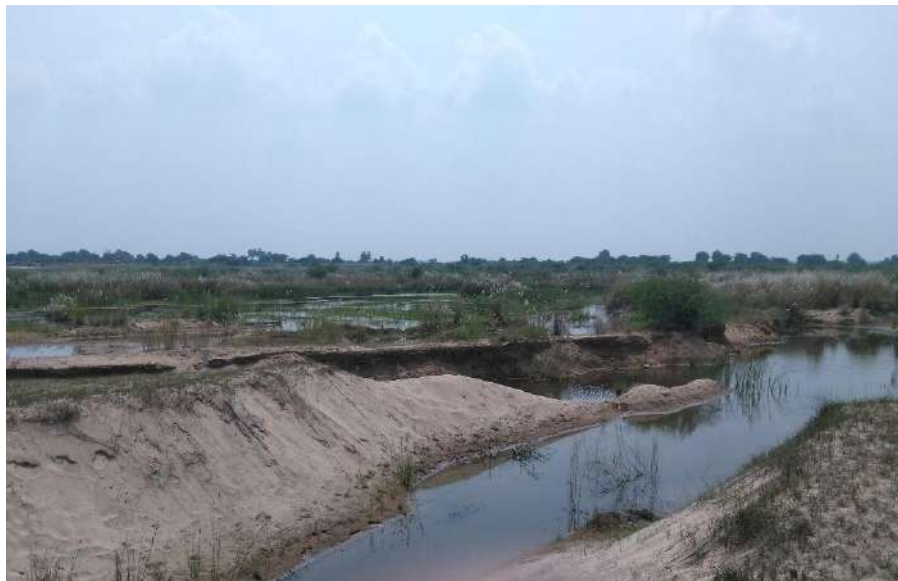
**Fig. 100:** Sand mining in the depositional patches of KR\_22; water level is nearly 2.5 m below the surface;  
downstream view
